RARITAN RIVER BASIN  
MANALAPAN BROOK, MONMOUTH COUNTY  
NEW JERSEY

# MILLHURST LAKE DAM

## NJ 00296

### PHASE 1 INSPECTION REPORT NATIONAL DAM SAFETY PROGRAM.

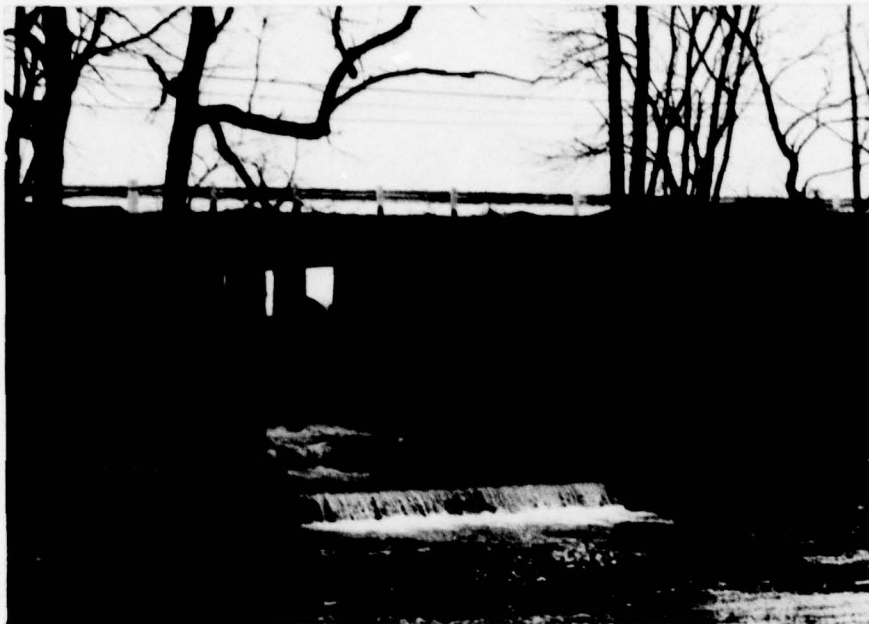
Photo No. 1 - Overall view of spillway, apron and bridge structure from downstream. Note the cracking and undermining of the wingwalls.

3. Provide concrete underpinning at the toe of the wingwalls, and replace the missing masonry wall with concrete. This work to be commenced within six months.

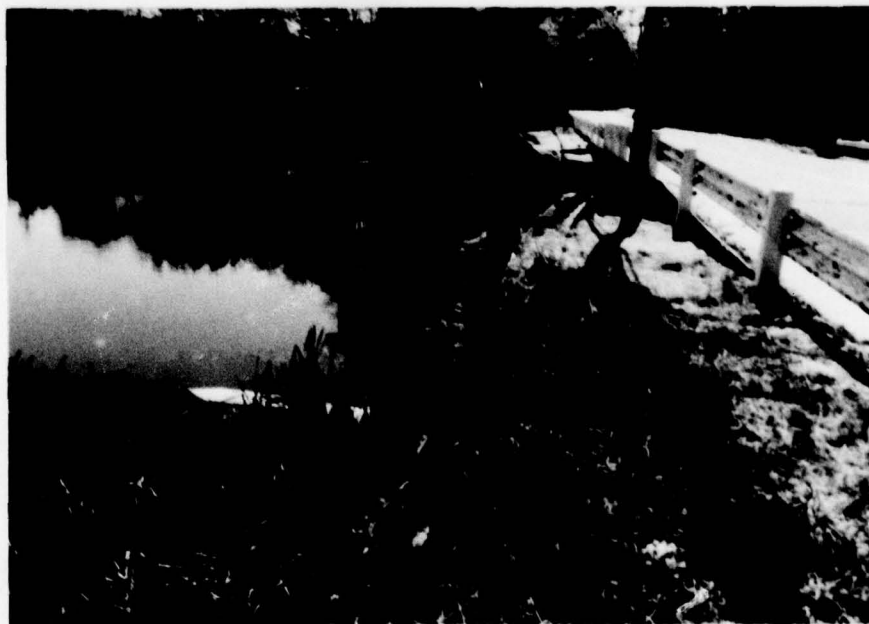
Photo No. 2 - Overall view of upstream face of dam. Note the debris interceptor upstream of the spillway.

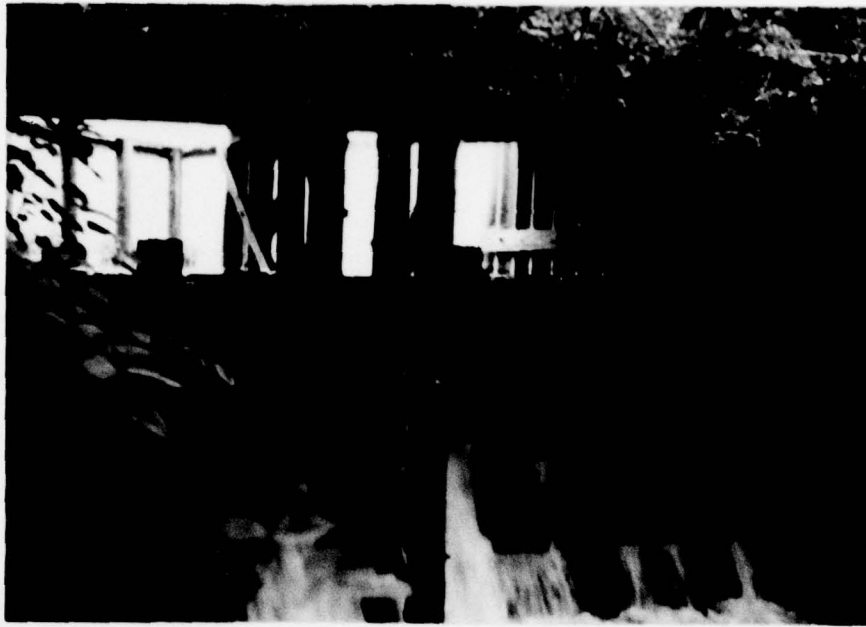
Photo No. 3 - View of concrete ogee weirs with a double stop-plank gate in the center. Note the timber bridge support and the timber bridge deck.

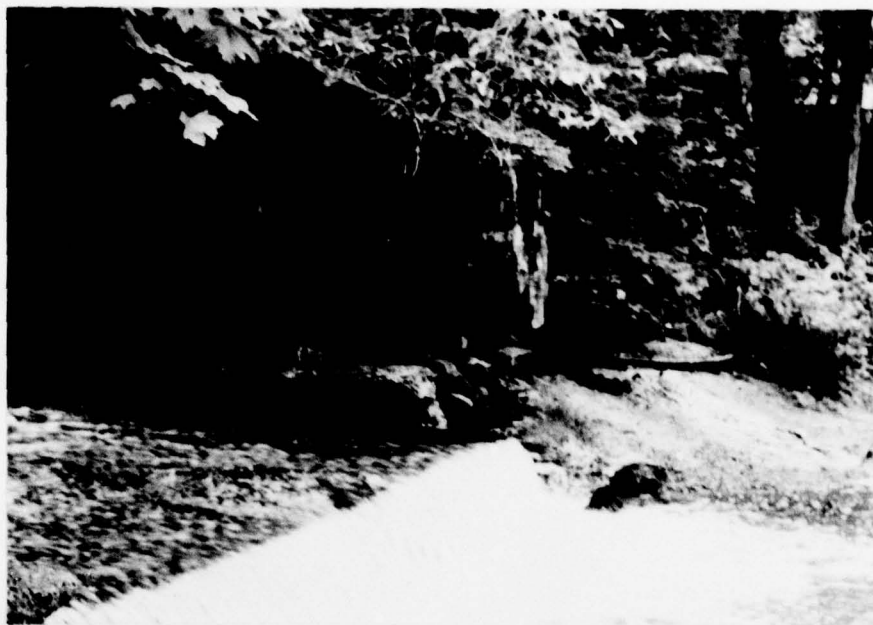
Photo No. 5 - View of left wingwall, showing seepage at the toe of the embankment. The wingwall has been undermined and the concrete repair is also deteriorated. Tree roots are promoting deterioration.

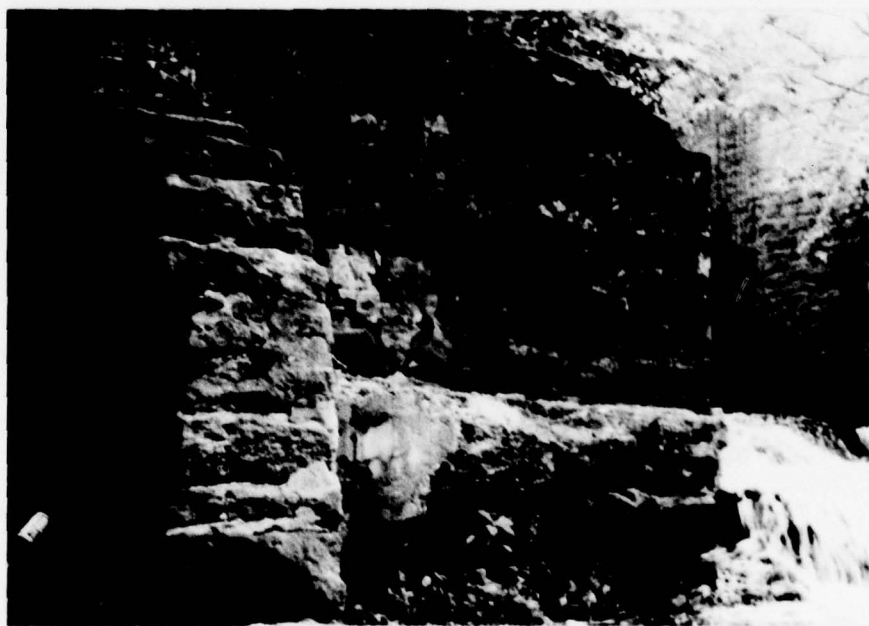
Photo No. 6 - Detail of toe of right wingwall showing severe settlement cracks and undermining.

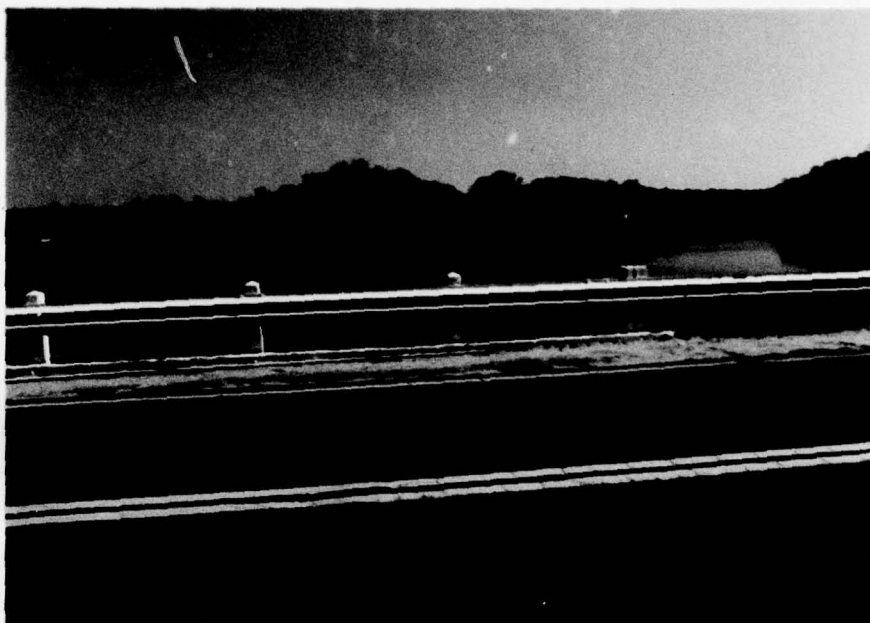
Photo No. 9 - General view of Millhurst Lake looking upstream. Note the moderate, wooded slopes and the accumulation of silt and weed at the rim.
